**EMERGENCY SPILLWAY PERFORMANCE,  
UPPER RED ROCK CREEK WATERSHED,  
OKLAHOMA**

**ARS-S-108**

**May 1976**

By W. O. Ree<sup>1</sup>

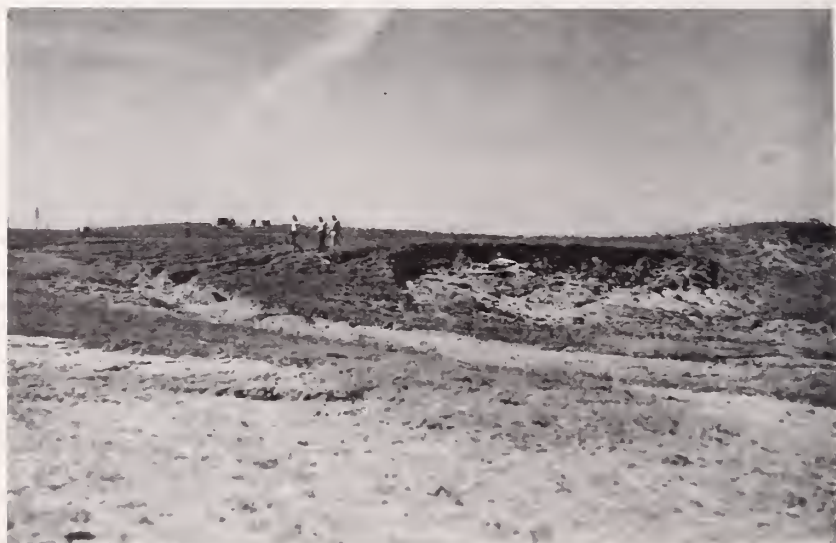
FIGURE 3.—Outlet end of site 24 emergency spillway after flood of October 10-11, 1973.

upon which the spillway discharges. The badly scoured portion to the right is on the bank of a natural channel or gully alongside the emergency spillway and was attacked by overflow from the spillway. Figure 4 shows the rills in the lower end of the spillway.

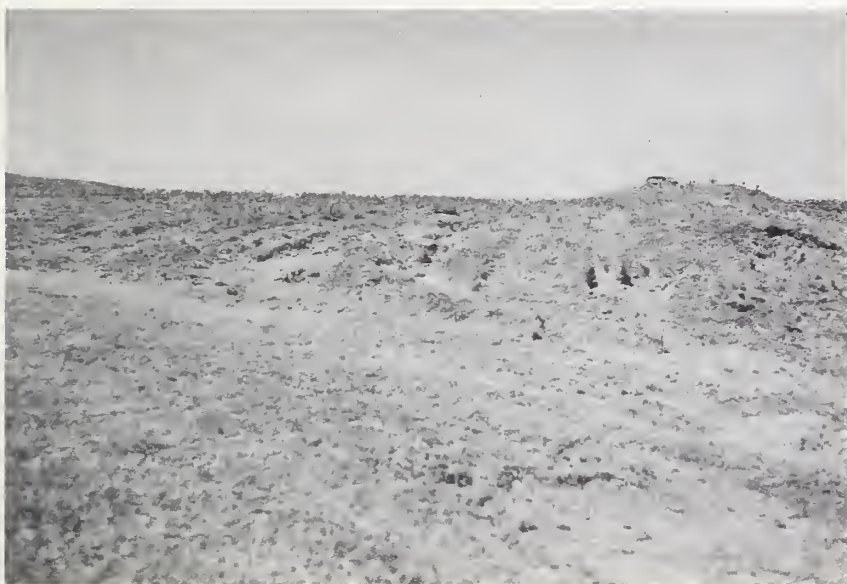
FIGURE 4.—Lower end of site 24 emergency spillway after flood of October 10-11, 1973.

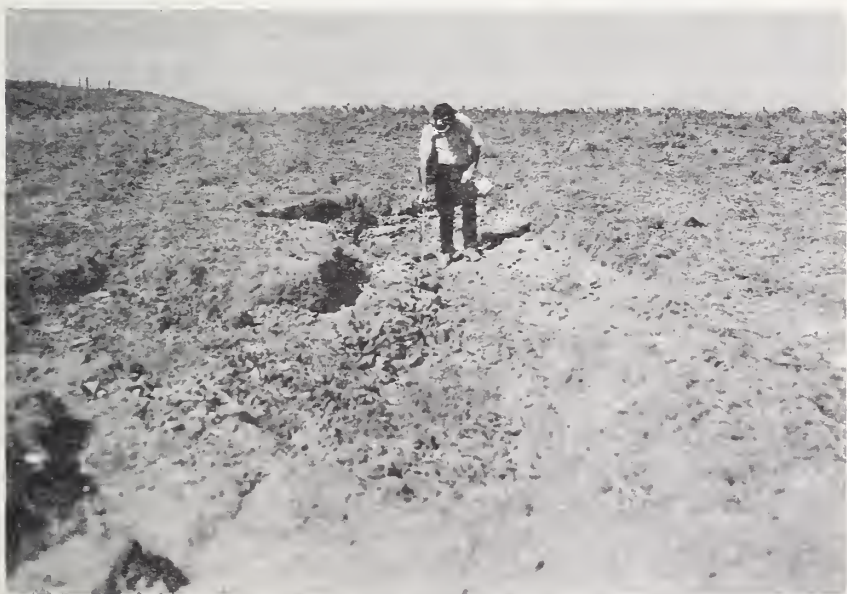
FIGURE 5.—Two-foot scour to the shale bedrock 90 feet downstream from site 24 spillway crest.

Figure 5 is a closeup view of the head of one of the deeper rills. The scour here is about 2 feet deep and extends to the shale bedrock. This part of the spillway was subjected to the 6.7 feet per second flow velocity. Immediately downstream of the spillway crest is a small area scoured to a depth of 5 inches (fig. 6).

The site 24 spillway started to erode during a flow event which had a peak mean velocity of 6.7 feet per second. The spillway appeared to have been heavily grazed, and this may have been responsible for its condition. Cattle trails and “stomp” areas were present in the spillway at the time of inspection. Therefore, it is reasonable to assume that the eroded areas also had suffered from similar cattle activity.

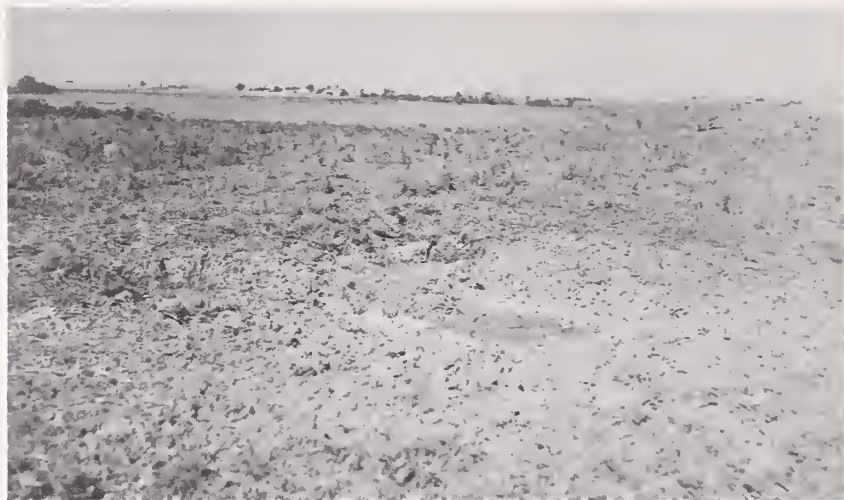
FIGURE 6.—Scoured area in site 24 spillway just downstream from spillway crest. The cover on the adjoining area is thin, poor, and short.

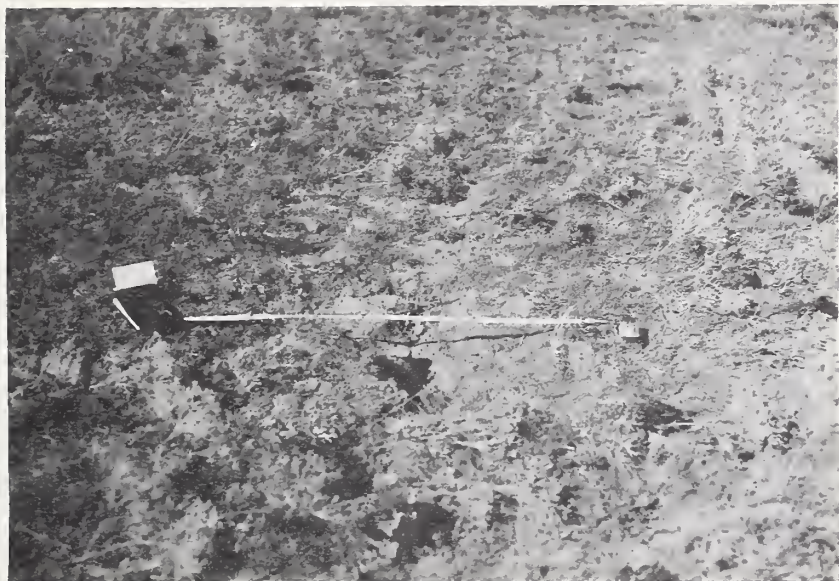
The spillway was in excellent condition after the flood. Some slight erosion was evident about 20 feet downstream from the crest and about 40 feet in from the right bank (fig. 8). It is not known whether this eroded area was present before the flood or whether there had been a weak spot in the cover here. An overall view of the spillway is shown in figure 9.

FIGURE 8.—Closeup of most eroded portion of site 25 emergency spillway after flow event of October 10–11, 1973. This point in the spillway is located approximately 20 feet downstream from the crest and about 40 feet in from the right bank. There appears to be more broomweed here, which may be a weaker cover in this area. Its appearance before the flood is not known.

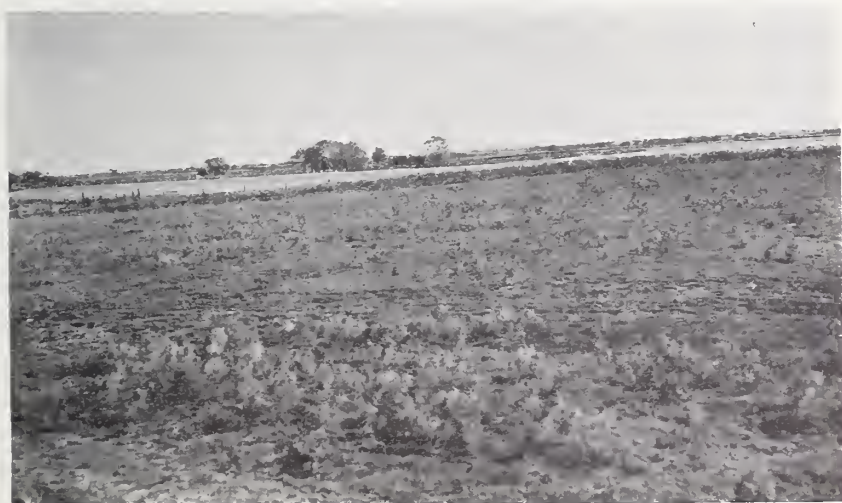
The excellent condition of the spillway should be expected because the flow velocity of 5.6 feet per second is below a suggested permissible velocity of 8 feet per second for a bermudagrass cover on clay soil and slopes of less than 5 percent, as determined from the "Handbook of Channel Design for Soil and Water Conservation" (cited in footnote 2). Uniformity of cross section and cover and moderate grazing can also be given some credit for the fine performance of the spillway.

FIGURE 9.—Overall view of site 25 emergency spillway after flow event of October 10–11, 1973. This spillway is in excellent condition. The cover is closely grazed bermudagrass, with a scattering of broomweed and some small, fine-leaved grass.

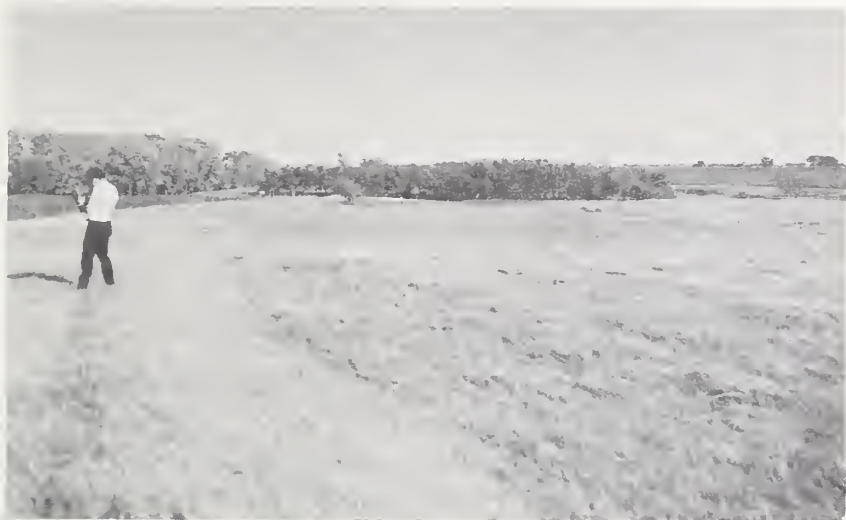
The flow velocity in the upper part of the spillway was estimated to have been 1.0 feet per second at the peak of the flood. This low velocity did not erode the spillway; the grass has hardly been disturbed. Figure 11 shows the crest of the spillway after the flow.

FIGURE 11.—Crest of emergency spillway, site 30. The cover is an excellent stand of bermudagrass.

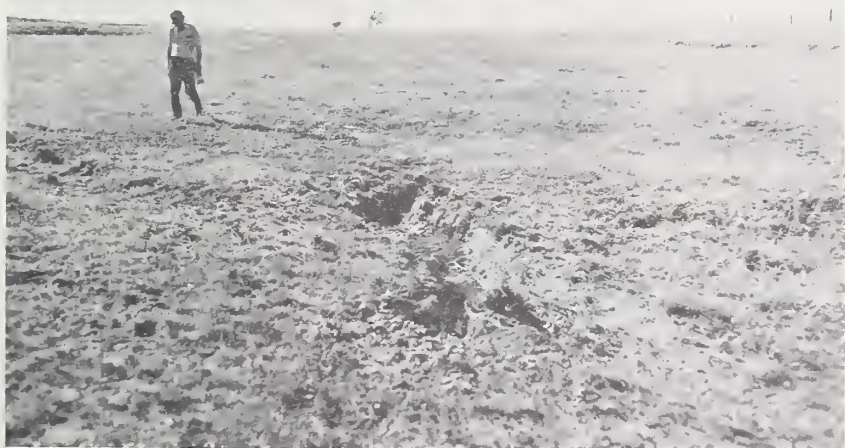
the topography of the site. A small gully has formed here (fig. 12). (It may have been there before, only to be enlarged by the flood.)

FIGURE 12.—Small gully at outlet end of site 30 emergency spillway. Concentration of flow and the poor cover may have caused this minor failure.

Second, at the outlet the spillway was gradually deepened at the centerline so it could join the existing draw in a smooth transition. The flow is concentrated at the deepest point of the spillway,

where the velocity is highest and where the gully starts. (It could eventually reach the center.) A level sill and a low drop structure at the terminal end of the spillway would eliminate the need for the deepening that threatens the stability of the spillway. This would be a practical solution only if the grass could be relied upon to provide protection against erosion in the channel upstream from the terminal structure. If the grass lining is not dependable, there would be no point in using a terminal structure because the spillway could still fail from erosion above the structure. Again, the exploration of this idea is left for future consideration.
